2014-04-02 2000z*S69 X02*

2014-04-03 0200z*S66 X01*

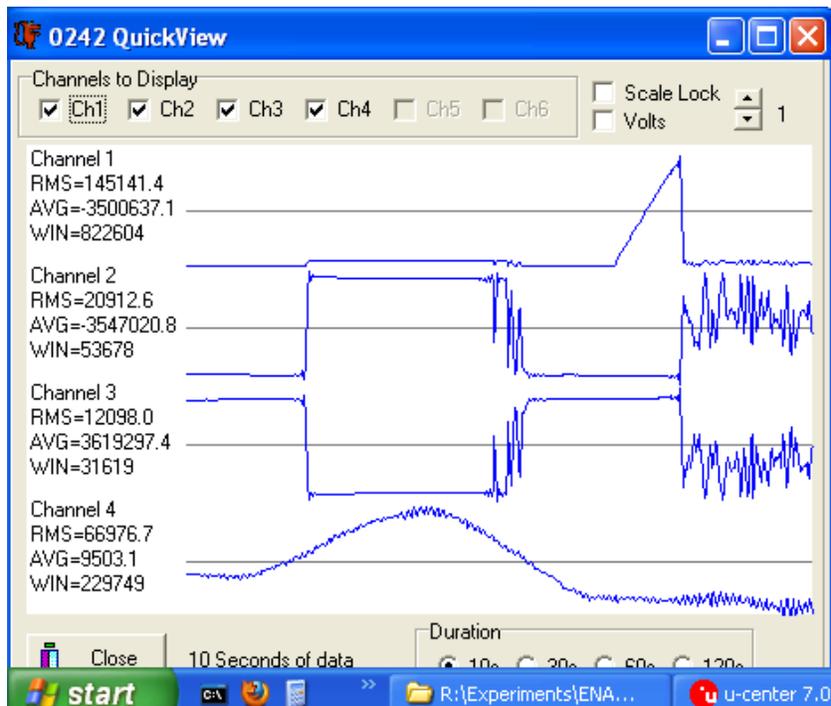
S30

Guralp looks funny. Deploy here as it is probably better than the Guralp which was shipped unlocked. This is a less critical site.

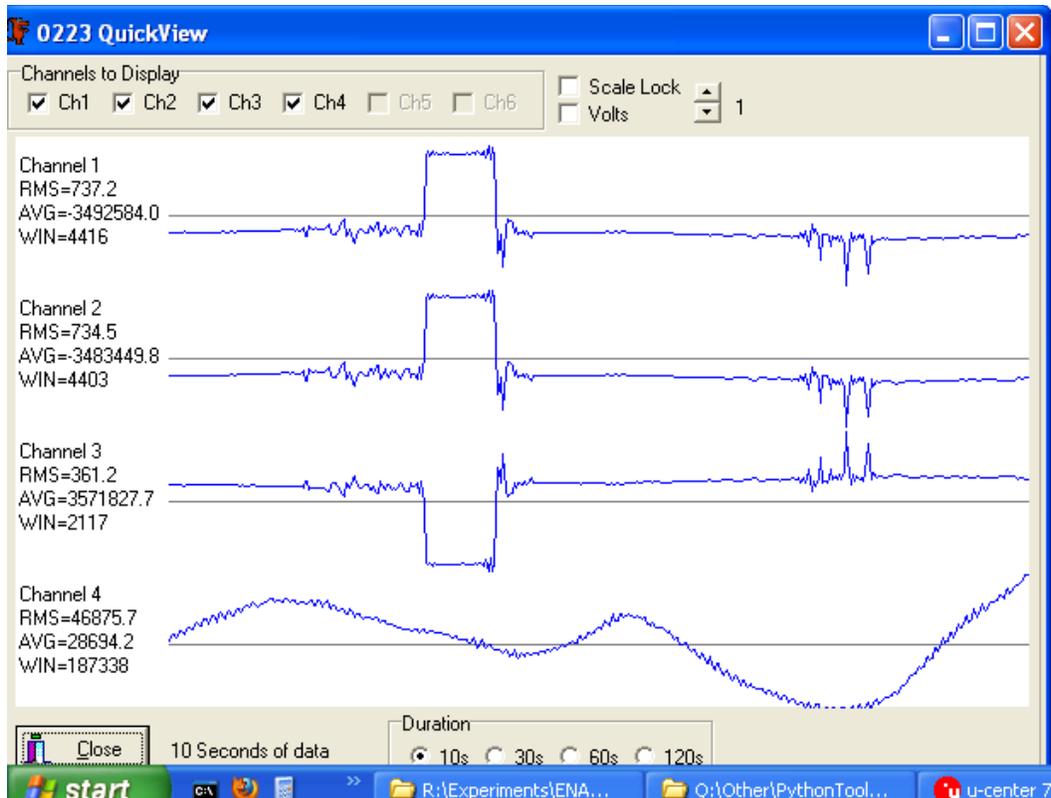
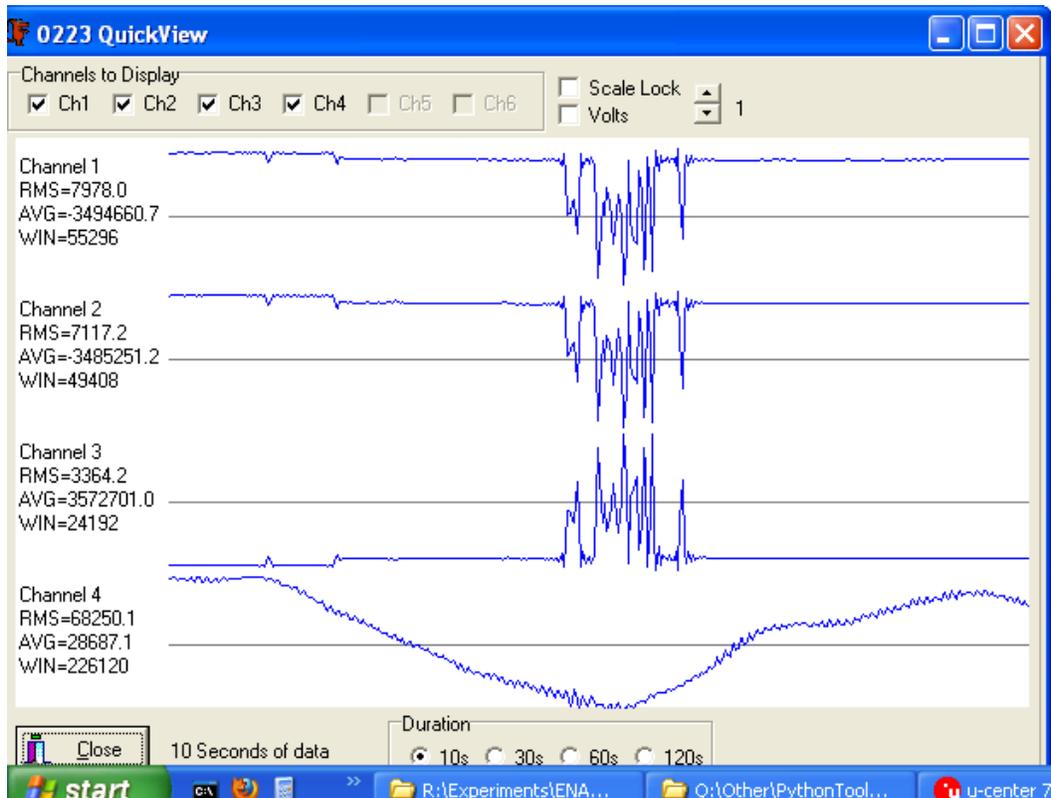
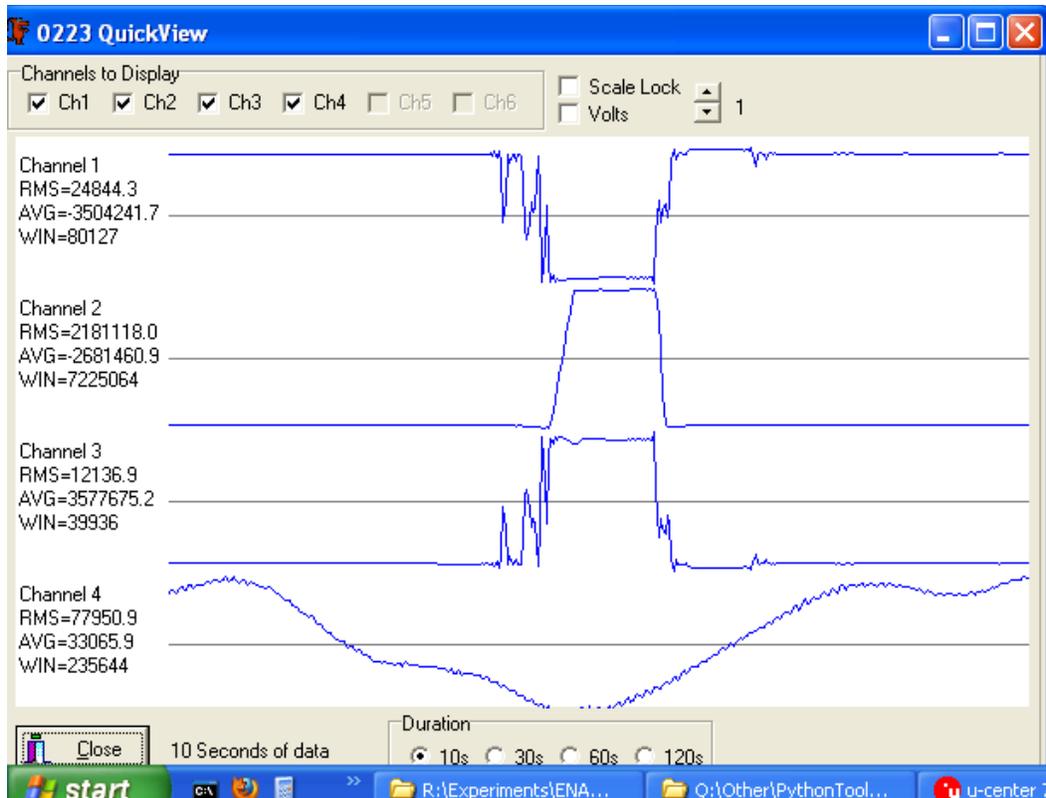
S38 a01

Looks like Channel 2 of Guralp may be unlocked. Even after two lock commands it has occasional rail to rail swings.

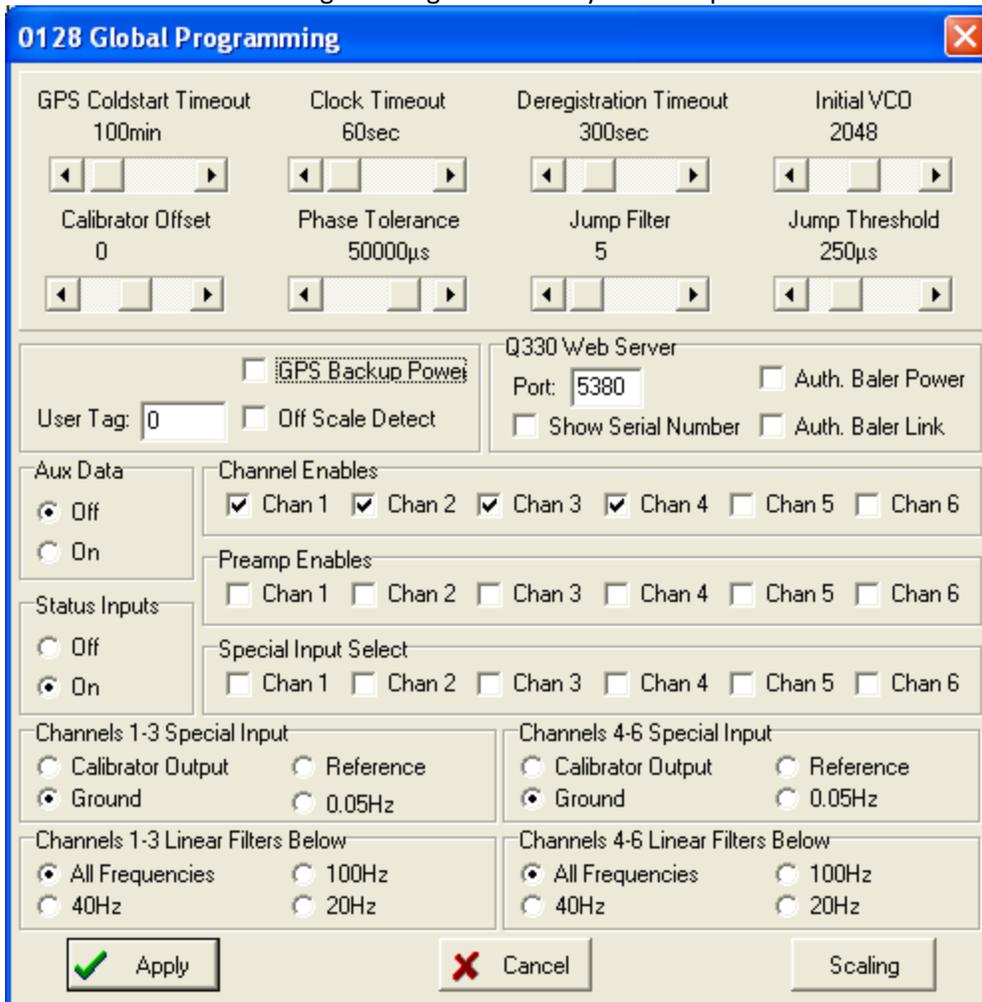
S28 x03
Q330 power cycled GPS receiver shortly after turn on. When I did xml compare shortly after this power cycle I got a comparison mismatch for gps_backup = 0. Normally this equals 1. It looks like this is visible in Willard in the Global Programming window only under expert mode:

Leave Q330 alone for a while and finally GPS lock is accepted. Now the XML comparison matches as expected, and GPS Backup Power is checked in Global Programming. Email from Joe confirms that this is expected behavior when the Q330 is cold starting the GPS. Seacon cable had no o-rings! No other issues.
